RESERVE STUDY FOR PIEDMONT HILLS

MAY 2016

Piedmont Hills Homeowners Association

Report #: 1

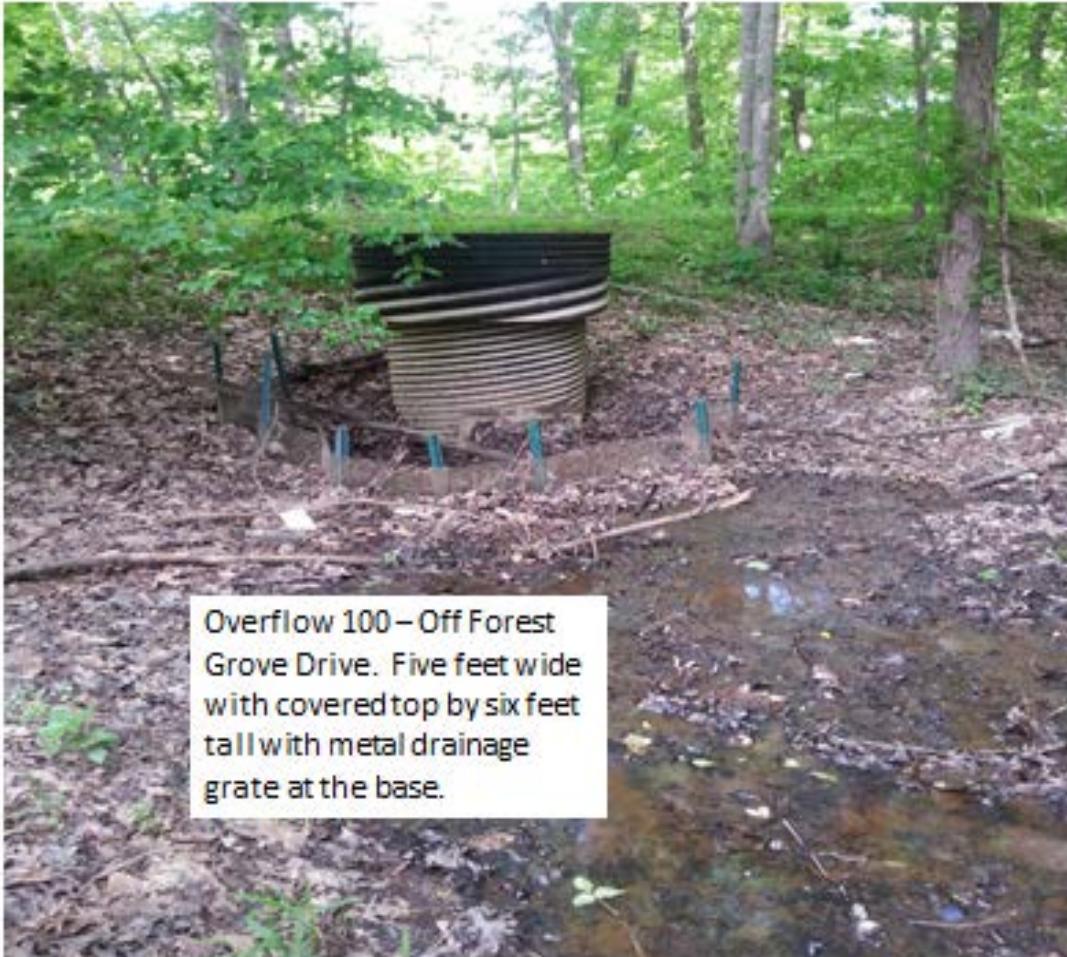
Exhibit 1

During my site inspection on 14 May 2016 I physically examined each retention pond and walked around the surrounding area. I found no major issues with the overflows, the galvanized metal of the overflows, metal grates, or any soil erosion at the base of the overflows. The land formed into a mound around the overflows showed no signs of deterioration or erosion.

Overflow 100 – Off Forest
Grove Drive. Five feet wide
with covered top by six feet
tall with metal drainage
grate at the base.

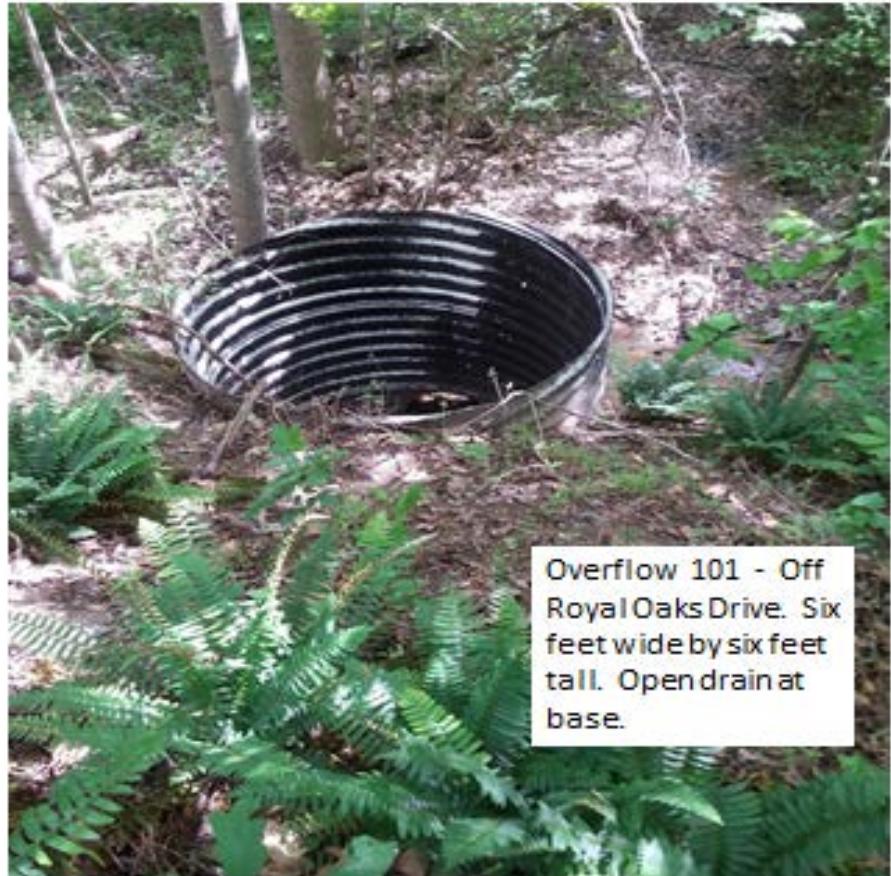
Exhibit 3

Overflow 101 - Off
Royal Oaks Drive. Six
feet wide by six feet
tall. Open drain at
base.

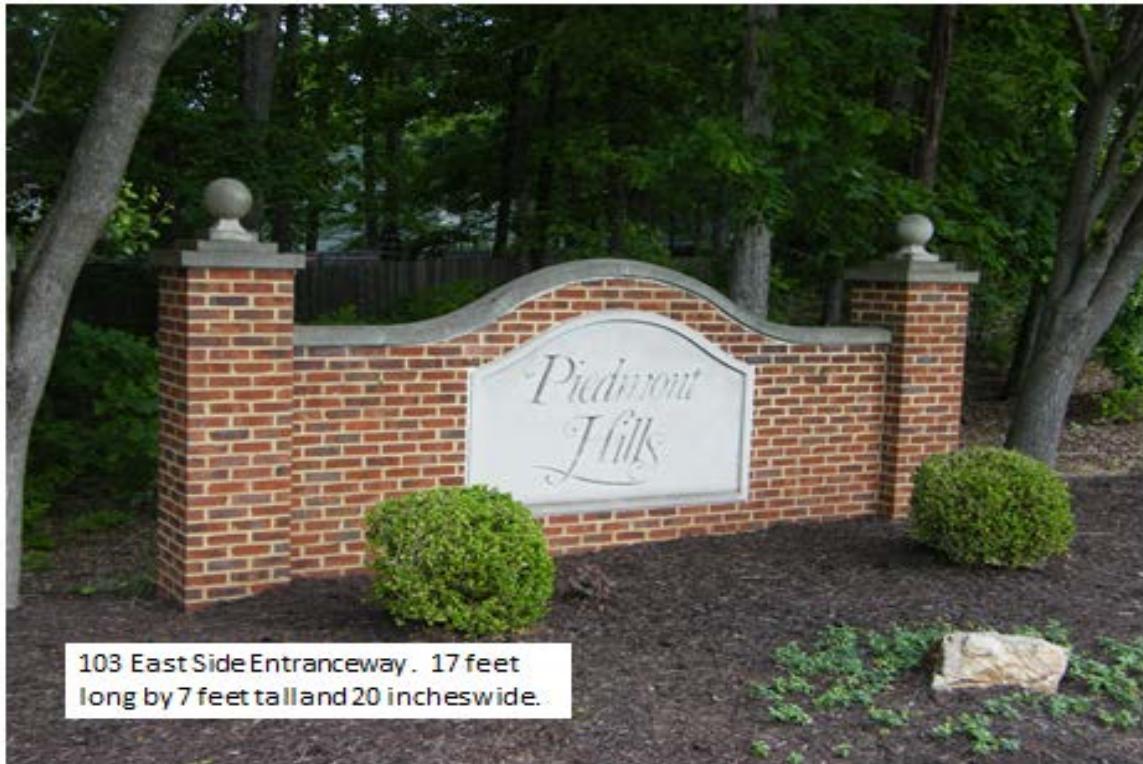
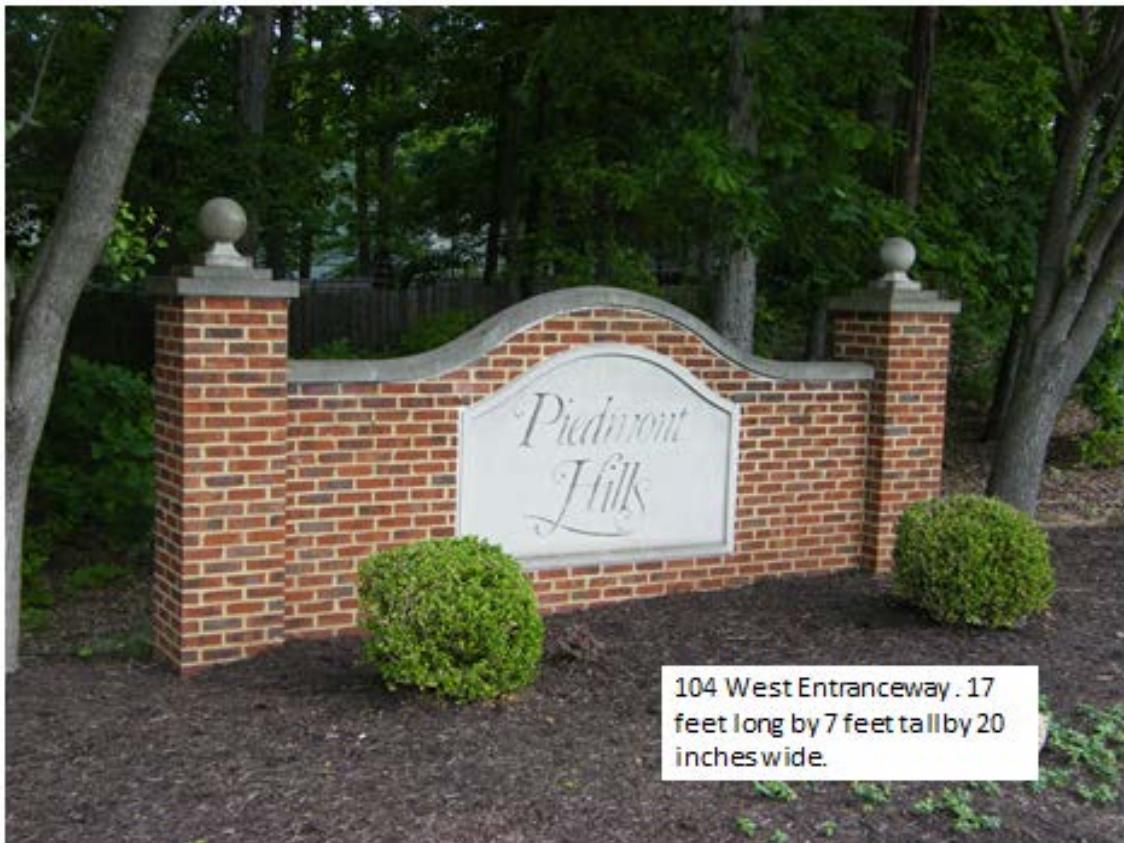
Exhibit 7

The entranceway signs were also inspected and no visible defects were noted. Both signs seem to be in good repair with no missing brick, mortar, or signs of degradation to the cement or brick. Even though the life cycle for the signs is rated at 30 years and there are 4 years remaining of useful life I feel unless the HOA wants a new design and no changes occur that the present signs could be used for many more years in their present state.

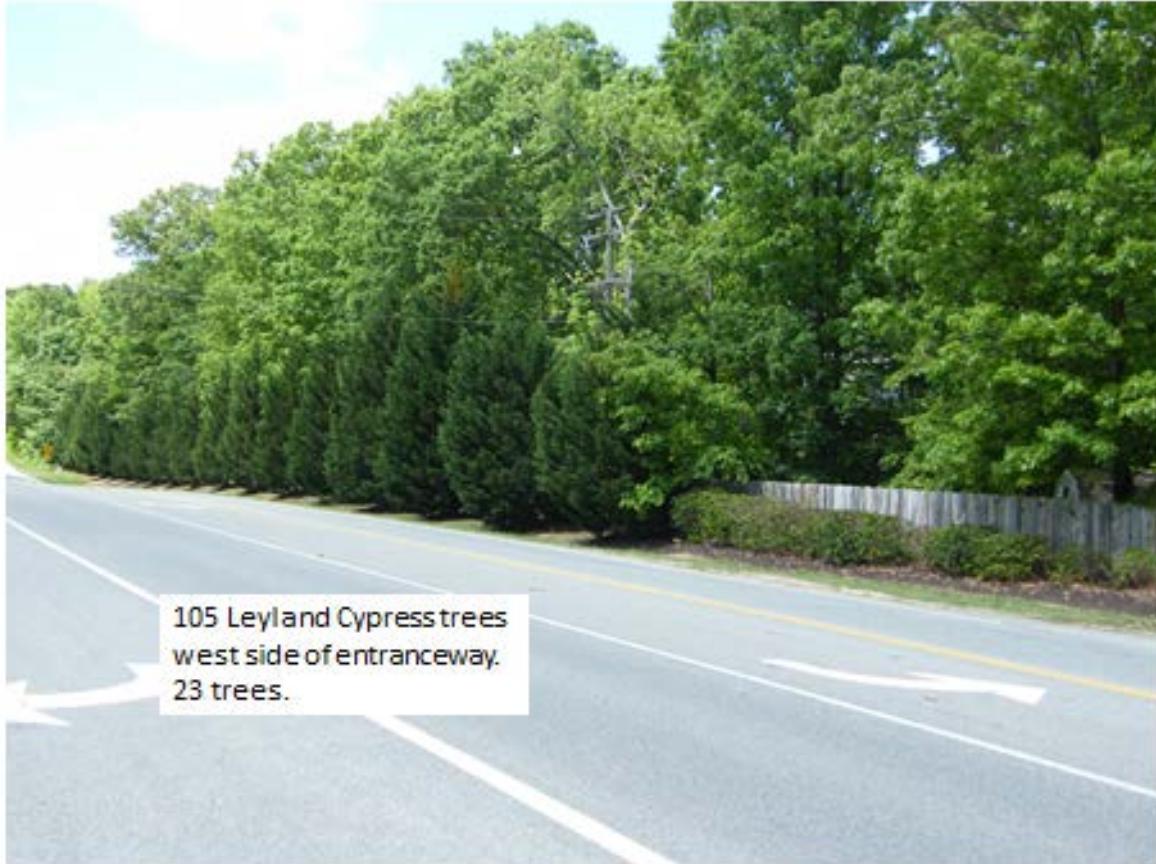
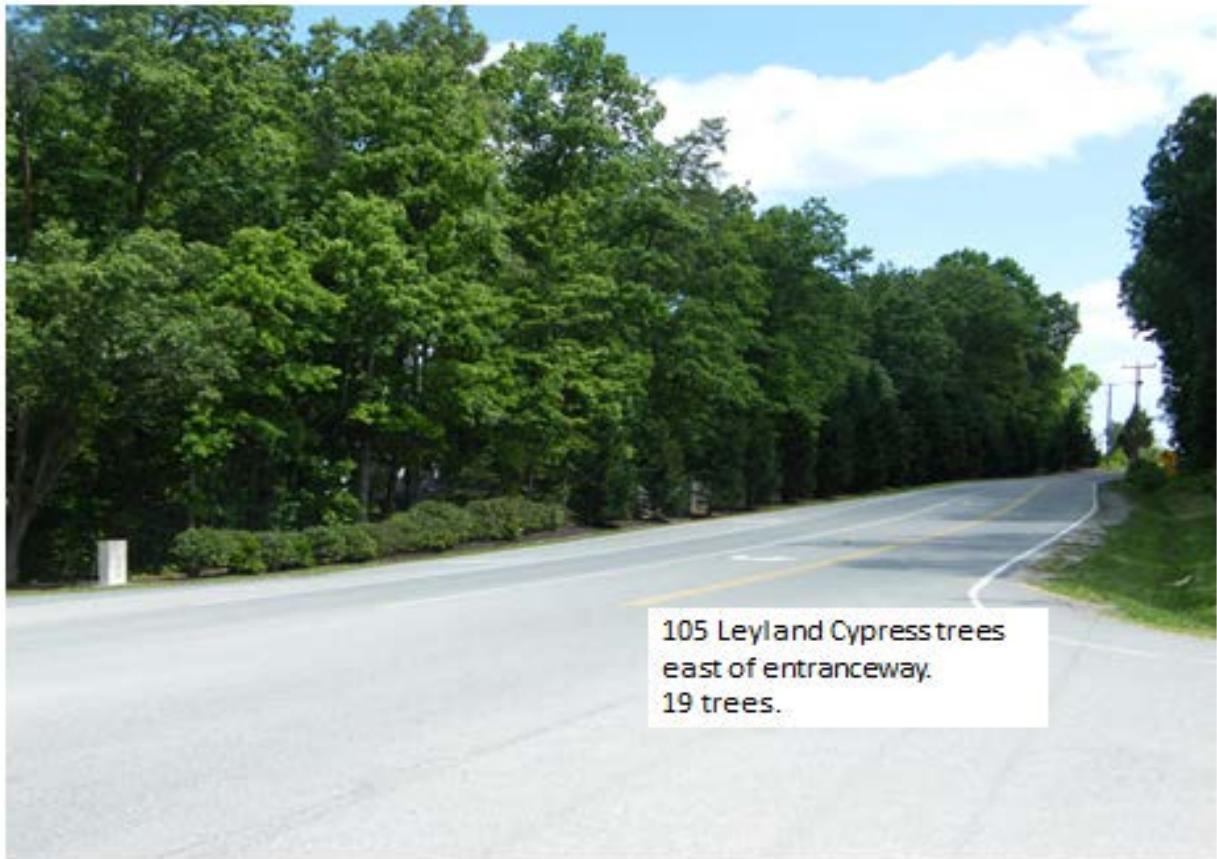
Exhibit 9

The 42 Leyland Cypress trees on both sides of the entrance to Piedmont Hill on Piedmont Drive are in overall good health. Though not technically considered assets I believe they should be included in the initial report. They were sprayed last fall (2015) for bag worms and are scheduled to be sprayed this year (May 2016) for the same issue. The community bulletin board is in good shape and was installed in 2010.

105 Leyland Cypress trees
east of entranceway.
19 trees.
